# **BEHAVIOR OF TRADITIONAL TIMBER FRAME STRUCTURES SUBJECTED TO LATERAL LOAD**

**Robert G. Erikson**

**Richard J. Schmidt**

**Department of Civil and  
Architectural Engineering  
University of Wyoming  
Laramie, WY 82071**

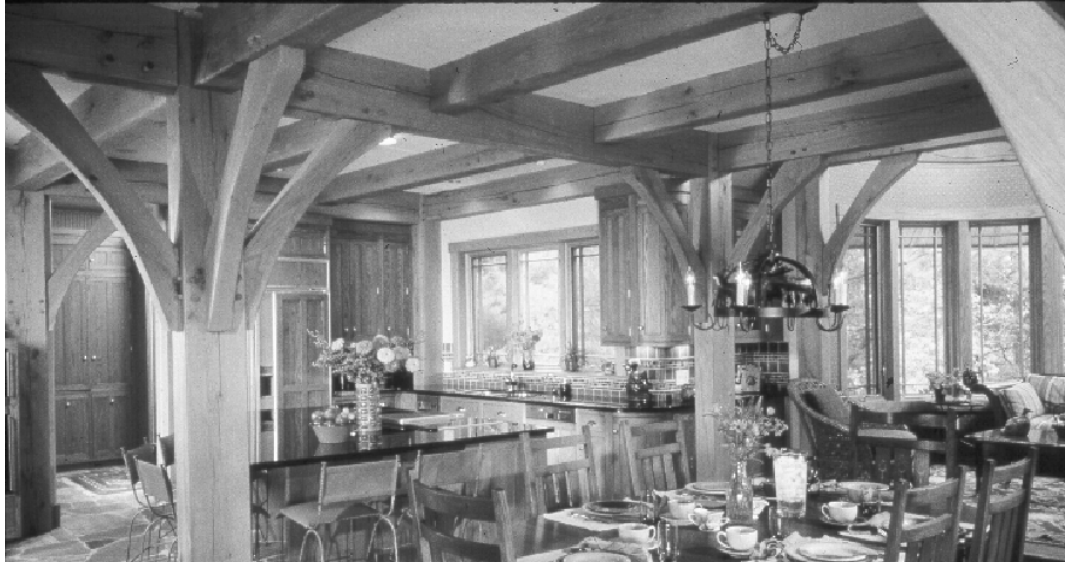
**Figure 1-1 Typical Timber Frame (courtesy of Riverbend Timber Framing)**

Timber frames are constructed as residences, public facilities, commercial and retail shops, and agricultural buildings. Historic covered timber frame bridges are common in the eastern United States. An example of the finished interior of a timber frame structure is shown in Figure 1-1. The photograph shows the large columns, beams, and knee braces typical of timber frame buildings along with traditional wood pegged, mortise and tenon joints.

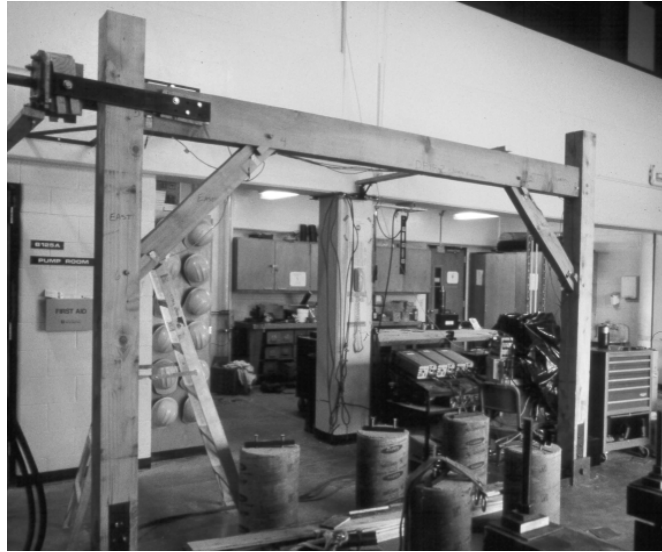
**Figure 2-1 1S1B Frame**

All frames had an 8-foot story height and 12-foot nominal bay width. Story height was measured to the top of the beam, and bay width was measured from center to center of the columns. A typical frame is shown in Figure 2-1.

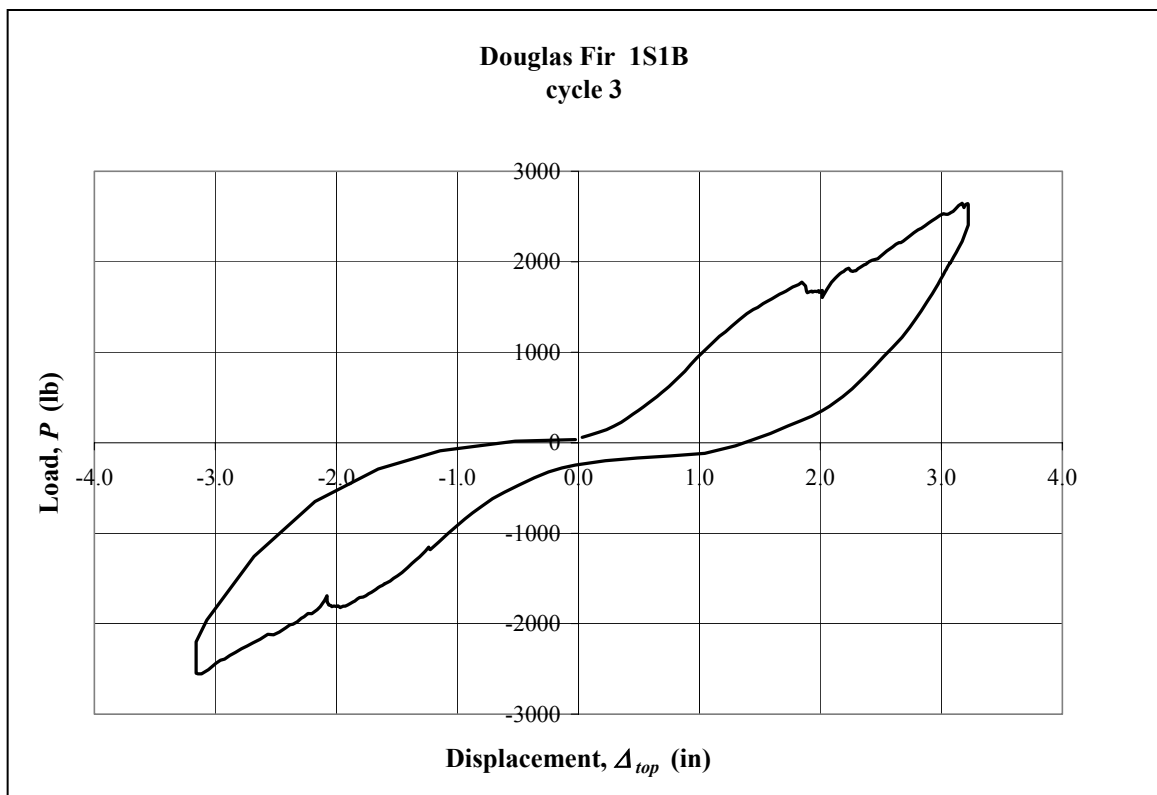
**Figure 2-25 Typical 1S1B Maximum Load Cycle**

Although there are spikes in the curve due to local failures, the frame continued to carry increasing load up to the maximum available displacement of approximately 3 inches. At such a high level of displacement, the frame is assumed to be well beyond any serviceability limit. Therefore, since this curve is typical of all frames examined, it can be concluded that stiffness, not strength, is likely to be the controlling design factor for unsheathed frames under lateral load.

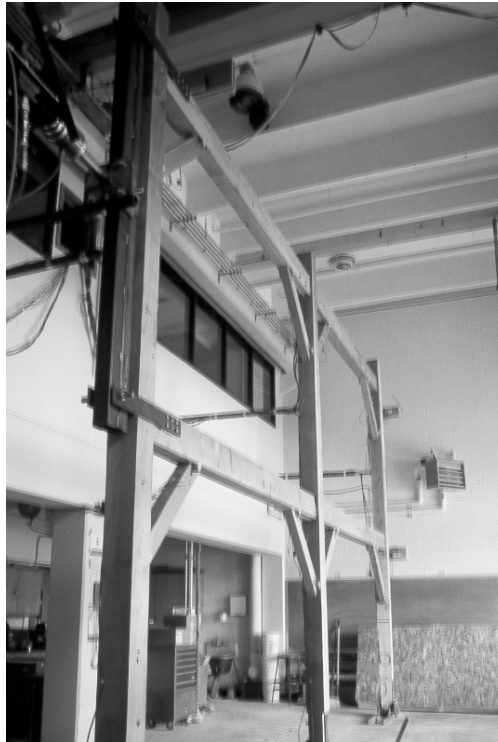
**Figure 3-1 2S2B Frame**

The frames had an 8-foot story height and 12-foot nominal bay width; thus these frames had a total height of 16 feet measured to the top of the upper beam and nominal width of 24 feet measured from center to center of the outer columns. A photograph of a typical 2S2B frame is shown in Figure 3-1.

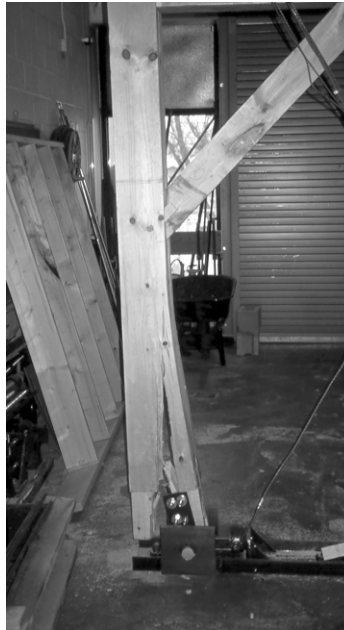
**Figure 3-13 Eastern White Pine 2S2B Column Failure at Reaction**

In order to cause failure of a frame, additional displacement in the push direction was applied to the eastern white pine and white oak frames. This was accomplished by applying maximum displacement, holding the frame and then resetting the actuator for three successive applications. As shown in Figure 3-13, the eastern white pine frame incurred a failure due to its attachment to the test fixture at an imposed top displacement of 7.9 inches.

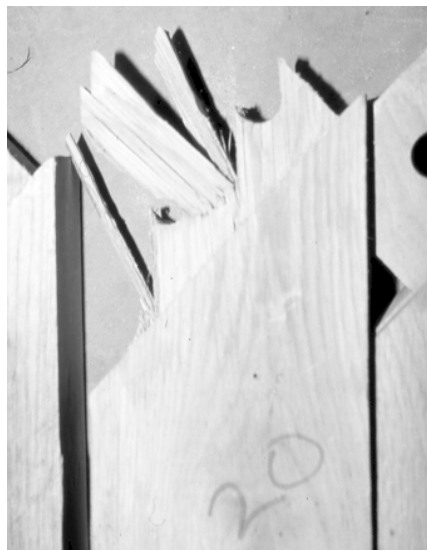
**Figure 3-14 White Oak 2S2B Knee Brace Tenon Failure**

The white oak frame was the only 2S2B frame displaced sufficiently to reach an ultimate load within the frame itself rather than at the support fixture. At an imposed displacement of 6 inches, several joints had failed but the frame continued to carry additional load. The failure of knee brace to column connection at joint 20 is shown in Figure 3-14 and Figure 3-15. The ultimate load was reached at an imposed displacement of 9.23 inches corresponding to an applied load of 15.7 kips. Ultimate load failure was characterized by mortise member (column) splitting at the upper beam to west column (joint 6).

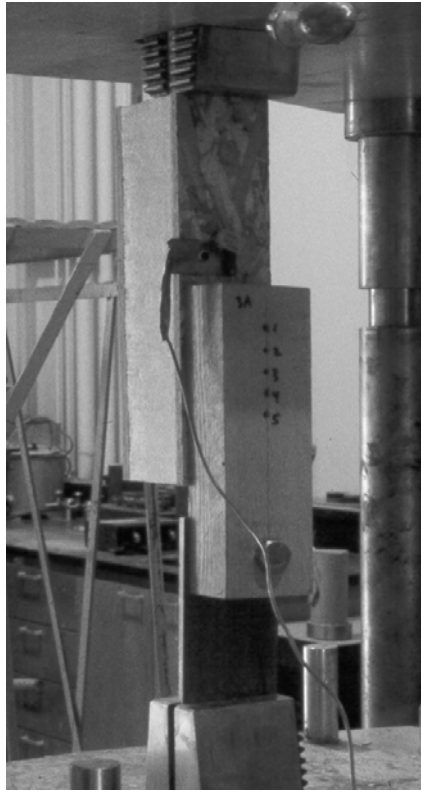
**Figure 6-2 Phase 1 Test Set-up**

The first phase of testing was conducted on a Tinius Olsen hydraulic test system. Ram pressure was measured with a pressure transducer and converted to load within the data acquisition software. Slip between the SIP specimen and the timber was measured with a 0.5-inch linear potentiometer. Actuator displacement was controlled manually with the fluid flow-control valves. Although a target load rate was established with a chart of displacement versus time provided by the data acquisition system, the actual rate of displacement was slightly variable due to manual operation of the test system. The target rate for displacement was approximately 0.0005 inches per second.
